Cedar Lake, Scott County: 2014 AQUATIC VEGETATION SURVEY

Report by the Invasive Species Program – Division of Ecological and Water Resources
Minnesota Department of Natural Resources

Lake: Cedar Lake (DOW#70009100)

Date of Inspection (most recent): July 31, 2014

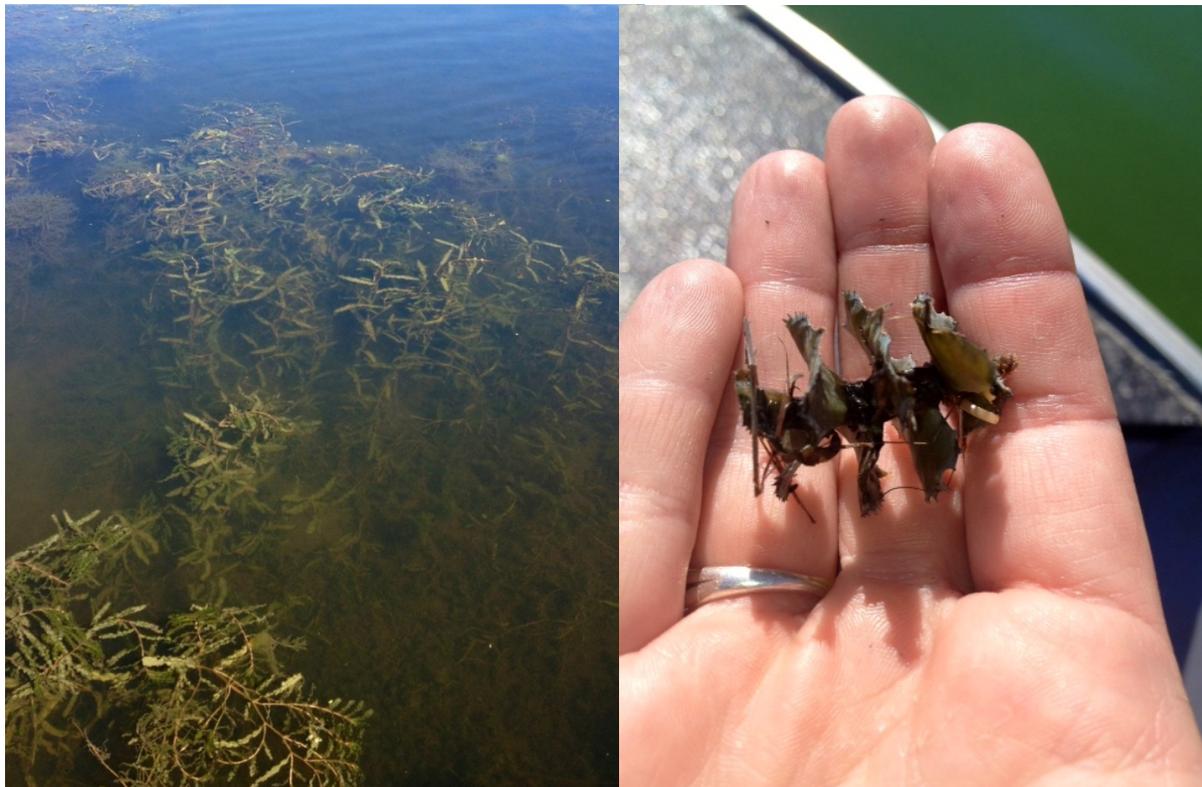
Figure 1. Surface matted curly-leaf pondweed (*Potamogeton crispus*) viewed during the 2012 aquatic vegetation point intercept survey alongside a photo of the turion or reproductive propagule of curly-leaf pondweed. Cedar Lake, Scott County (DOW# 70009100)

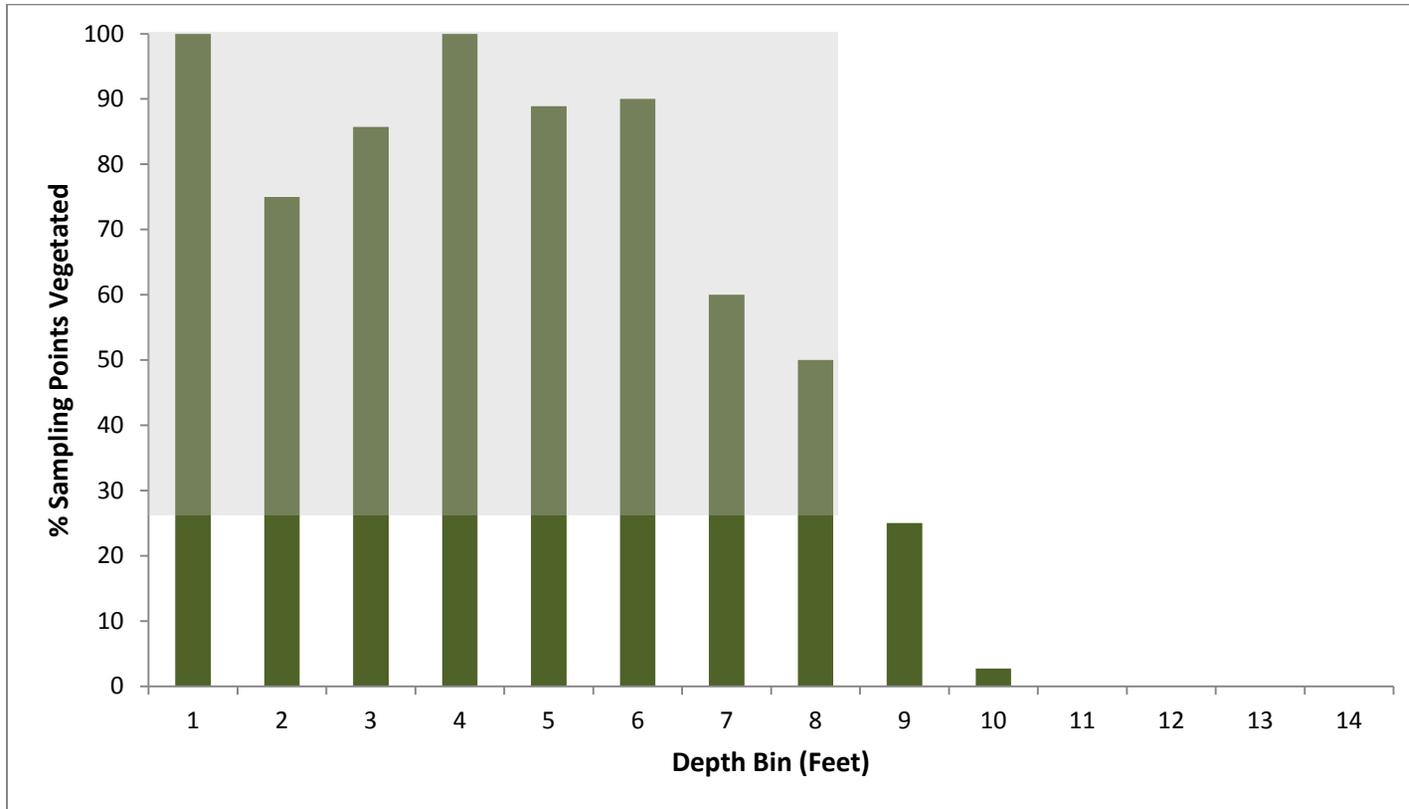
Figure 2. Maximum depth of plant colonization in feet during 2014 point intercept survey. Depths were binned in feet. Percent sampling points vegetated is defined as the number of sampling points with submersed vegetation divided by the total number of sampling points for each depth. Shaded area represents depth range of the 95th percentile of all submersed plants observed. Cedar Lake, Scott County (DOW# 70009100)

See Table 3 for a summary of calculations and Table 4 for historic plant frequency observations. Maximum depth of rooted vegetation was observed between 2.7- 3.3 meters (9-11 feet) from 2009 to 2014. See Figure 2 for depth of submersed plant data from the 2014 point-intercept survey. Native submersed plant frequency has increased from 3% to 25% since 2009. The mean

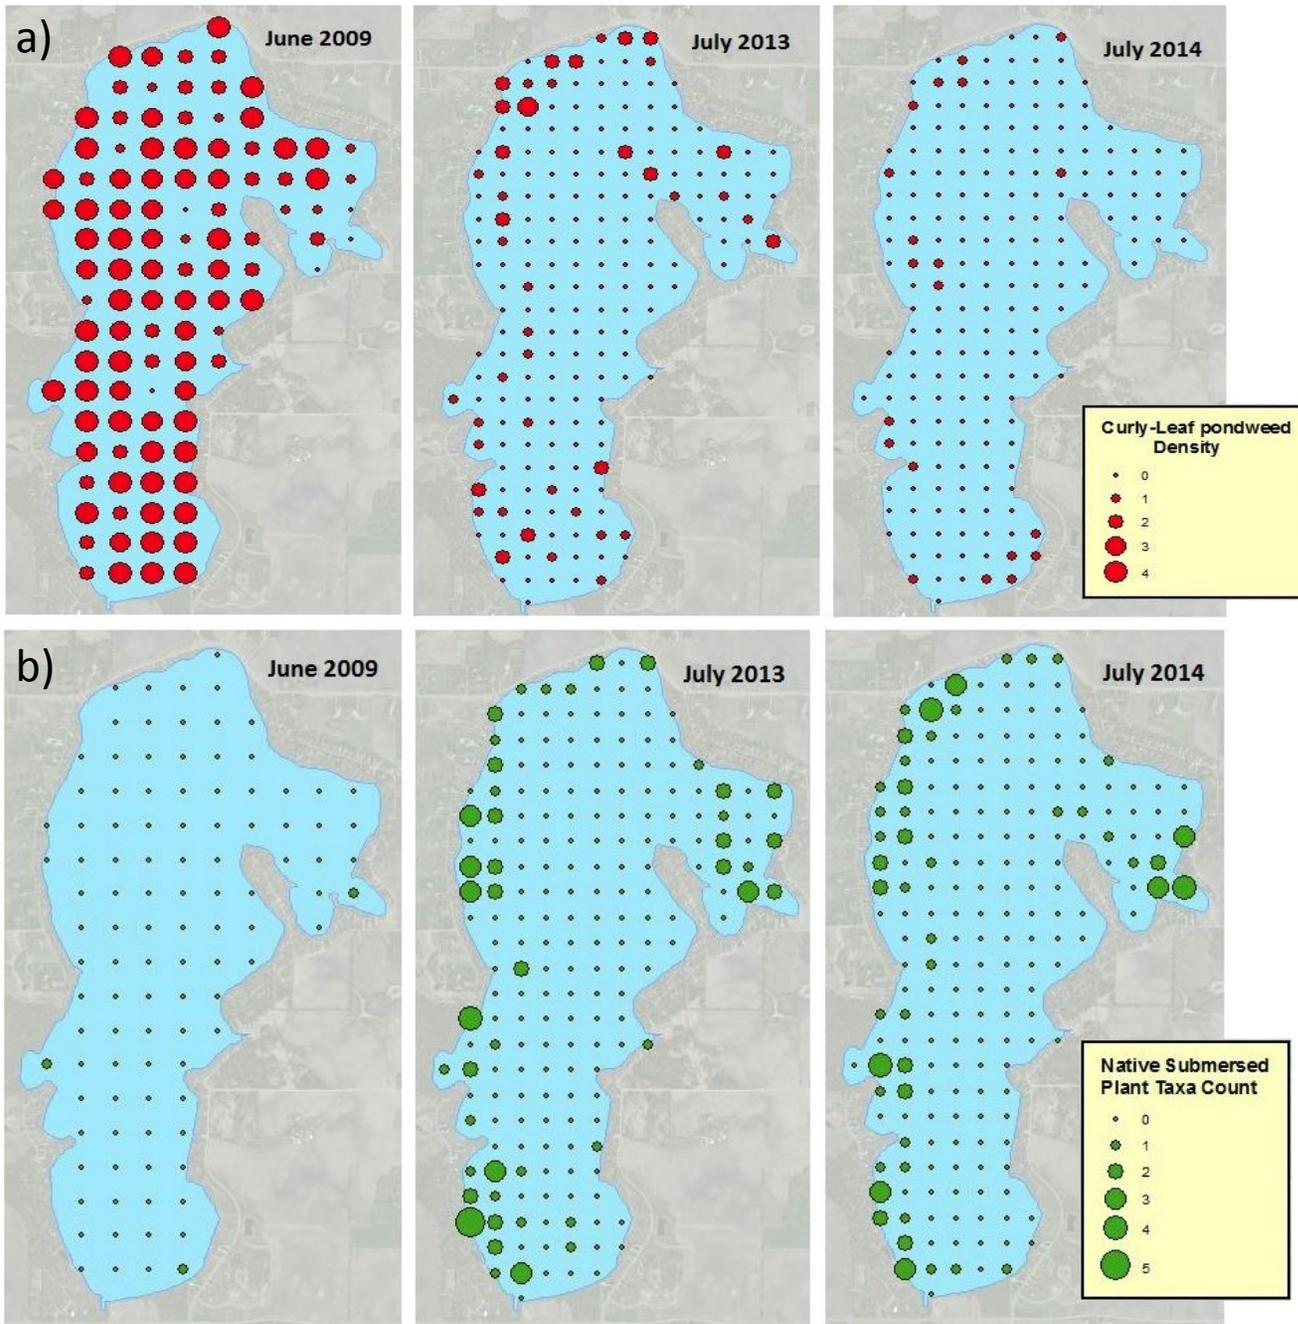
Figure 3. a) Spatial distribution and rake density rating of curly-leaf pondweed b) Spatial distribution and species richness (# of native species per sample point) of all native submersed plant species. Maps show distribution of submersed plants prior to LVMP variance (2009) and whole-lake treatments with variance approval (2013-2014). The LVMP will remain active until 2018. Cedar Lake, Scott County (DOW# 70009100)

number of native taxa per point has increased from 0.03 to 0.4. See Figure 3a and 3b for spatial distributions of curly-leaf pondweed and native submersed taxa from 2009-2014.
